## Mold Inspection Report

20307 Stetson Pl, Caldwell, ID 83605

February 4, 2025

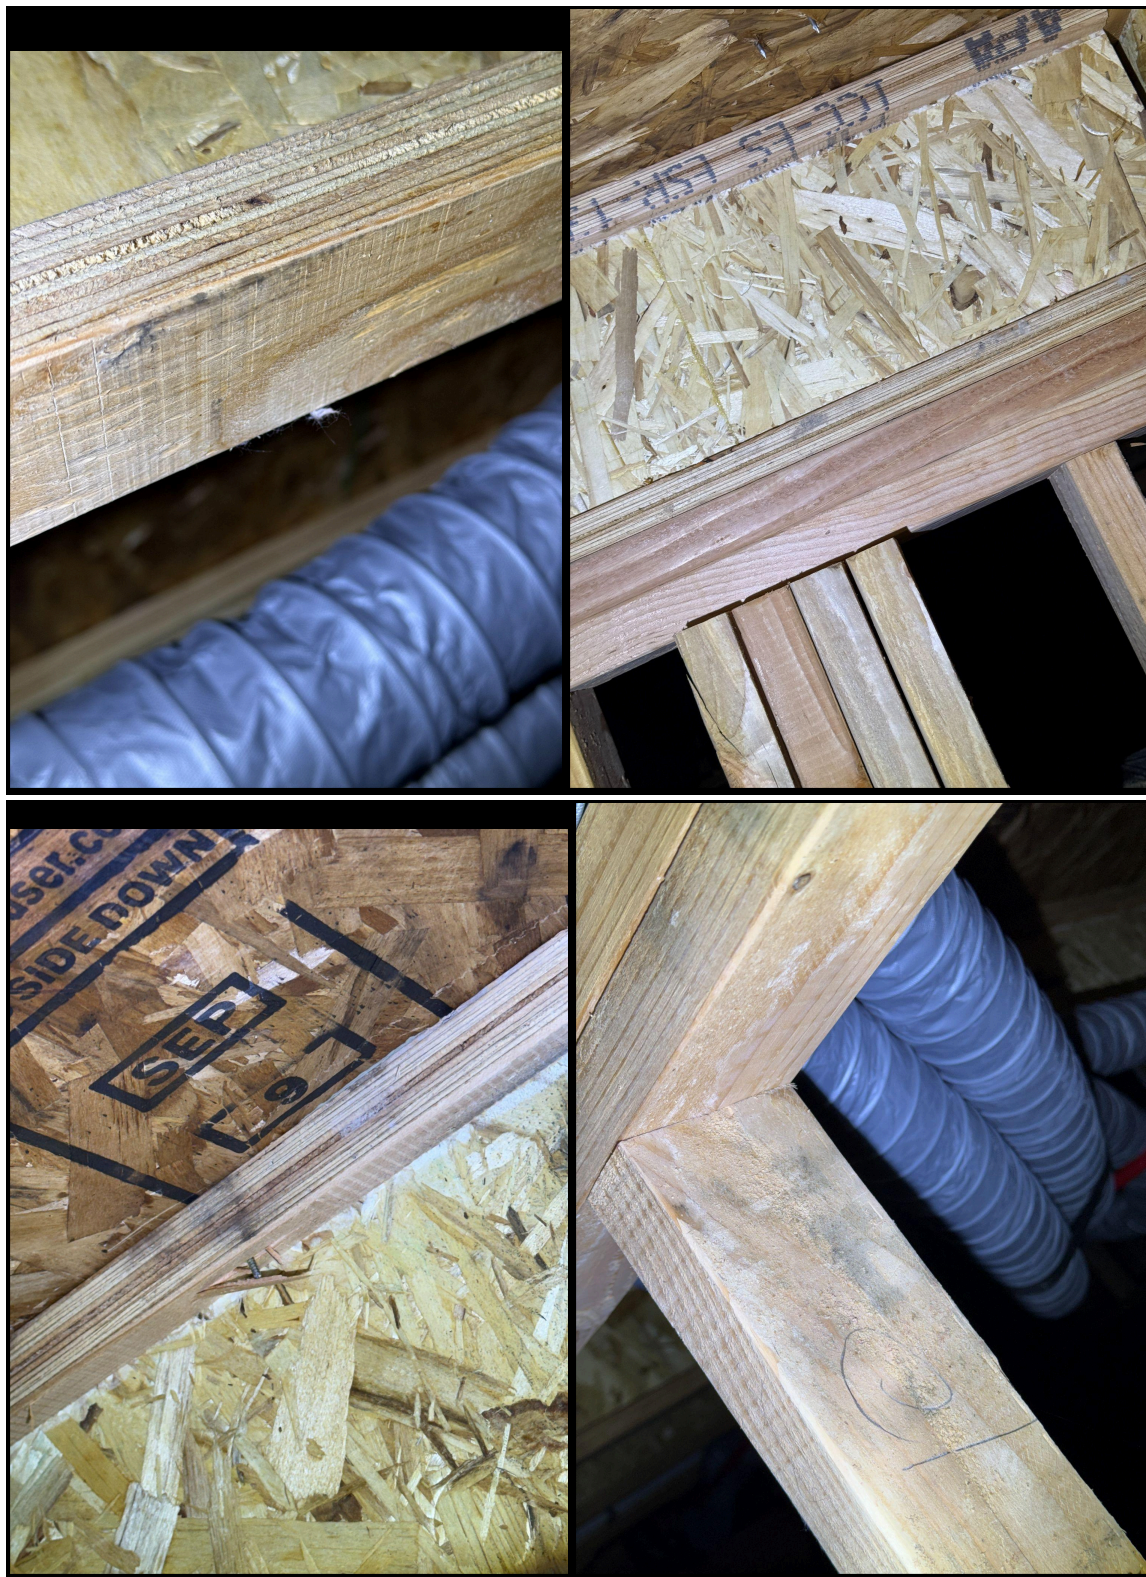
**Pictures of Areas:**

- **Location:** The mold-like growth was present throughout the crawlspace. It was primarily observed on:
    - Floor joists
    - Ponywalls
    - Bottom of the subfloor
  - **Extent:** The growth appeared to be minor but was dispersed in a scattered pattern, covering various surfaces within the crawlspace.
-

- **Antimicrobial Treatment:** All mold-affected surfaces in the crawlspace should be treated with EPA-approved antimicrobial agents to safely eradicate the mold and prevent regrowth.
